**PRELIMINARY ASSESSMENT
of
UNION PACIFIC RAIL YARD**

OKD987082930

**Submitted to EPA Region VI
May 22, 1991**

**Oklahoma State Department of Health
Solid Waste Management Service
Technical Programs Branch
Superfund Section
PA/SSI Staff**

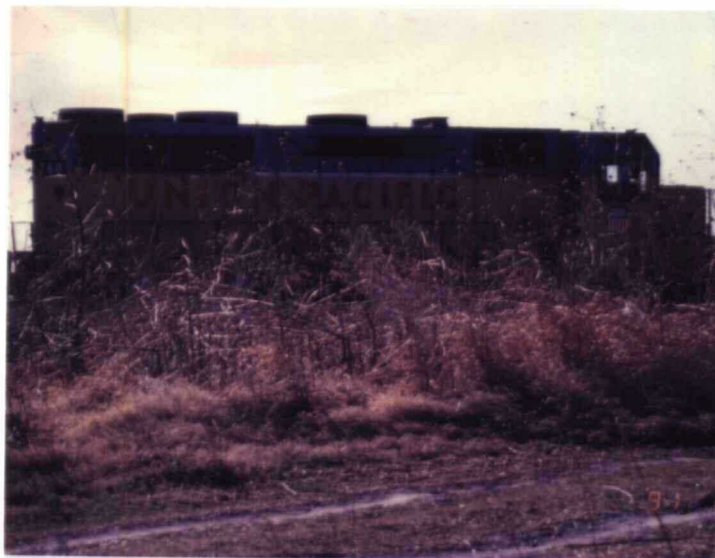
Photographer/ Witness *Matt Biddle*
 Date/Time/Direction *2-13-91/South*

Comments: *Abandoned Union Pacific Railway engine*

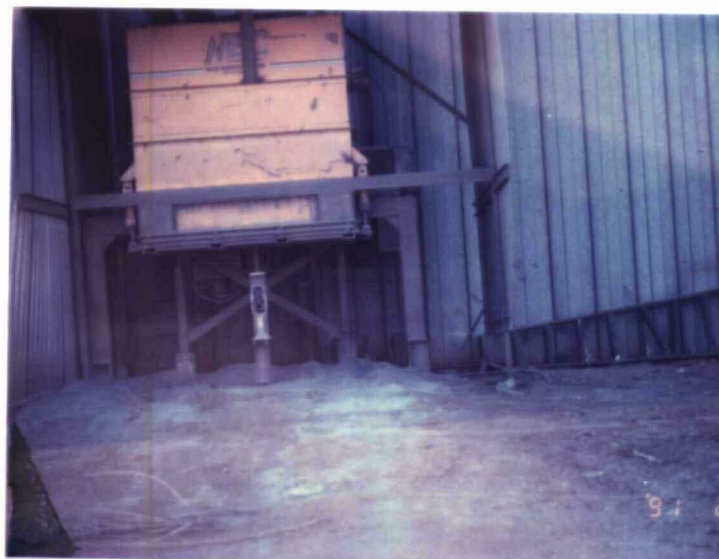
Photographer/ Witness *Matt Biddle*
 Date/Time/Direction *2-13-91/South*

Comments: *Pile and contaminated soils containing spent metal blasting material. North side of painting facility.*

At the time of the recent onsite reconnaissance, a 10 ft² pile and 1000 ft² of contaminated soils, containing spent metal blasting material, was observed adjacent and north of the facility. Additionally, a few opened drums and a couple of opened dumpsters were observed and paint solvent odors were detected in this same area. On the west side of the facility, 20 - 30 drums were also seen. Most of these drums were unlabeled and several were opened, and possibly contained the spent blasting material and paint sludges. (3).

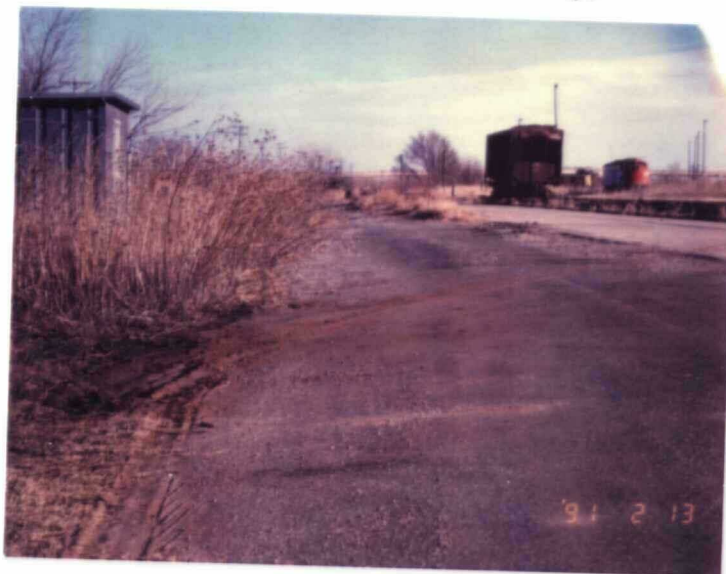
Photographer/ Witness *Math Biddle*
 Date/Time/Direction *2-13-91 / East*

Comments: *yard's northern access road with abandoned pump house to the left which provided pressured water to the freight car cleaning area to the right.*

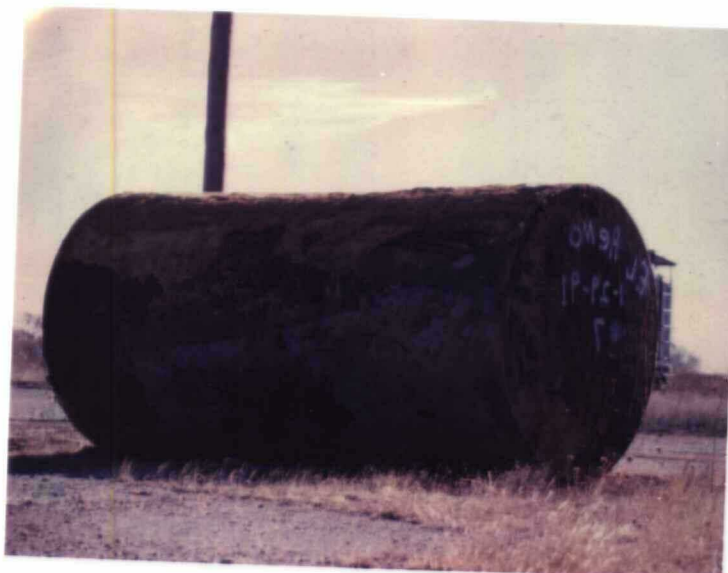
Photographer/ Witness *Math Biddle*
 Date/Time/Direction *2-13-91 / South*

Comments: *Pulled 45T, probably used for fueling the diesel engines.*

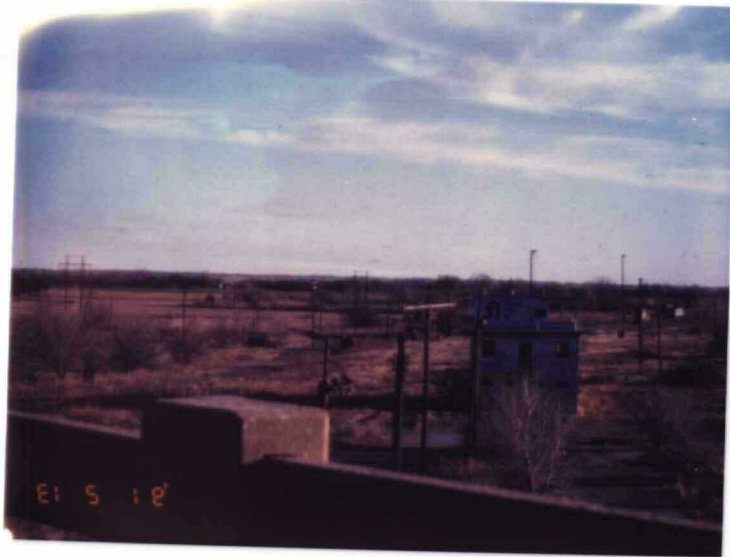
Photographer/ Witness *Math Biddle*
 Date/Time/Direction *5-13-91 /west*

Comments: *Picture taken of yard from 215 81 overpass.*

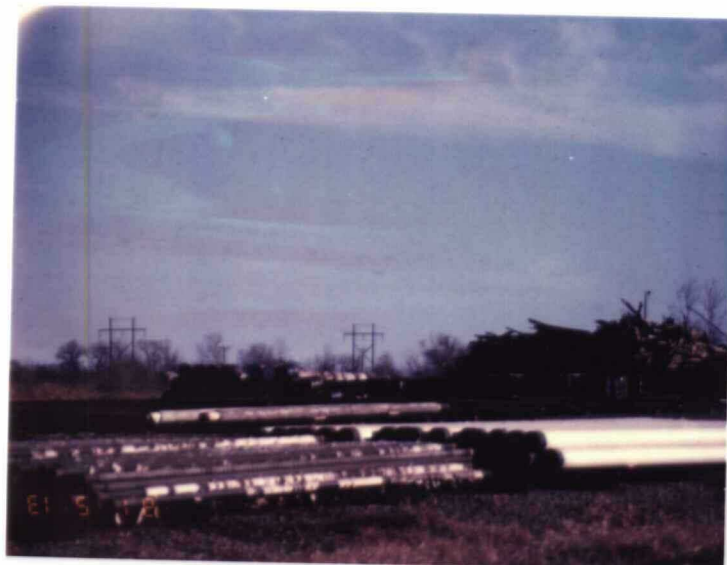
Photographer/ Witness *Math Biddle*
 Date/Time/Direction *5-13-91 /South*

Comments: *Adjacent pipe yard "Encoat"*

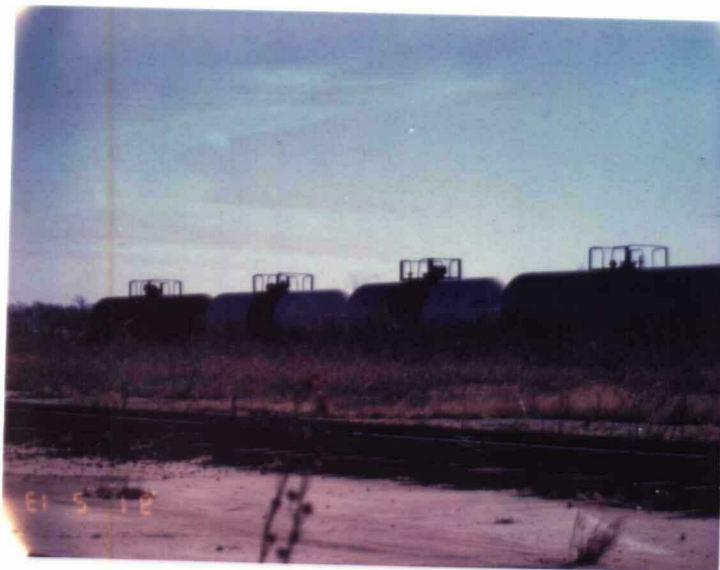
Photographer/ Witness *Math Biddle*
Date/Time/Direction *5-13-91 / South*

Comments: *Tank cars containing Phosphoric acid as labeled*

Standing next to a blue and white cinder block building which is empty and abandoned. Southeast of this building are 9 tank cars which are hooked together. They appear to be old and several of them are labeled "Phosphoric Acid" Some of the labeling on the cars indicates some are rubber lined. Several of the tanks are labeled "Farmland Industries lessee". Second tank from west says "Title to this car is vested in a trustee under an equipment trust agreement recorded in section 20 C of the interstate commerce act". Some dates on the two western most cars in this group are 7/83 and '85. No leaks were observed from the tanks.
